Notice of Violation

# RCRA COMPLIANCE EVALUATION INSPECTION REPORT

Keener Corporation

June 15, 2016

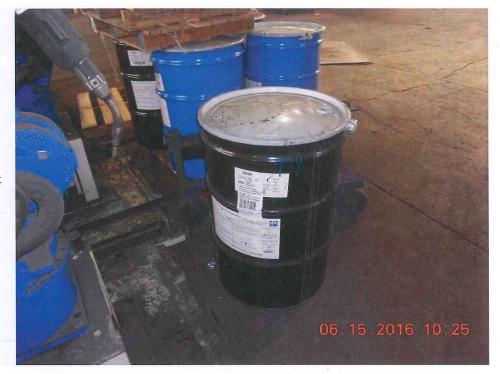
The inspector toured the site with Mr. Taylor. Numerous welding stations and four paint booths are located in a single building noted on Figure 1 (photographs 3-6). Paint booths were in operation at the time of the inspection. One 55-gallon container of paint waste was located in close proximity to a paint booth (photograph 1). The container was affixed with a product label, which identified the material as Aquacron WR Alkyd Gloss Ultra Deep Base (photograph 2). The container was closed and in good condition. Mr. Taylor stated Keener generates six to eight containers of this waste per month, depending on how often paint lines are flushed.

Container of waste paint located near a paint booth (black container). See photograph 2 for a picture of the label.

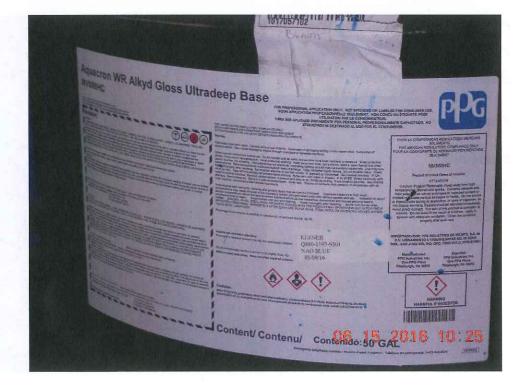
2

Label on the container featured in photograph 1.

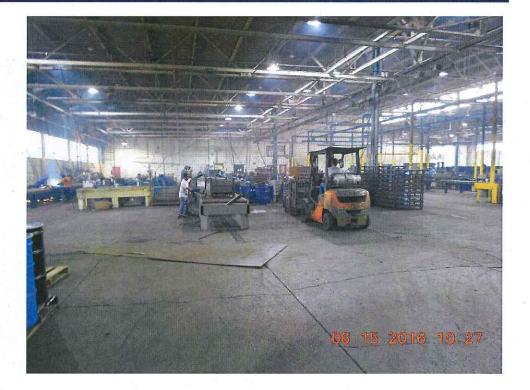
3

Welding stations.

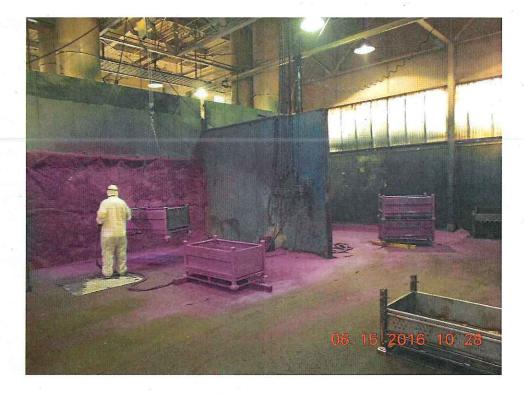
4

Two paint booths.

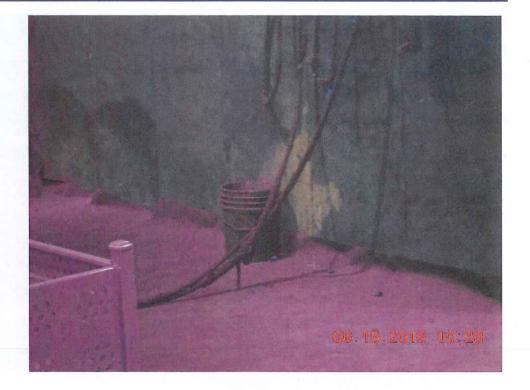
Bucket in paint booth featured in photograph 4.

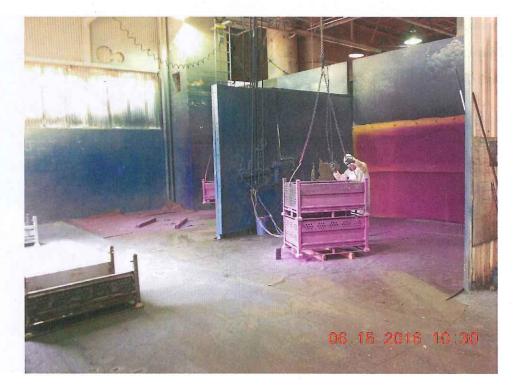
Two additional paint booths.

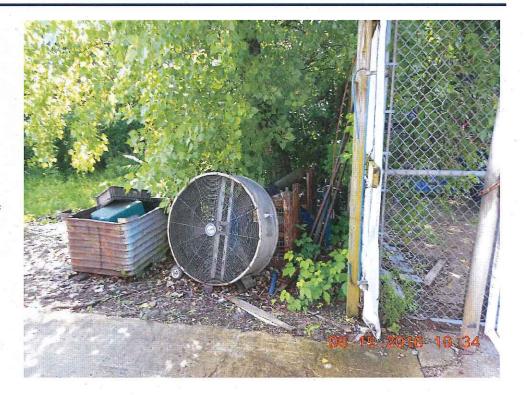
A small accumulation of refuse was located in an outdoor area in proximity to the Final Assembly Building. Gas cylinders were among the accumulation (photographs 7 and 8). Mr. Taylor stated the cylinders had contained argon and nitrogen gas.

Refuse located outside Final Assembly Building. Gas cylinders were included (see photograph 8).

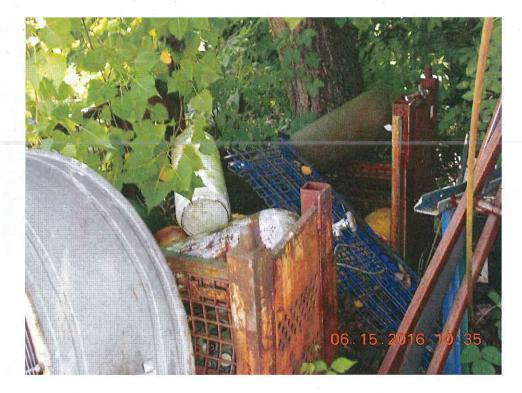
8

Gas cylinders among refuse featured in photograph 7.

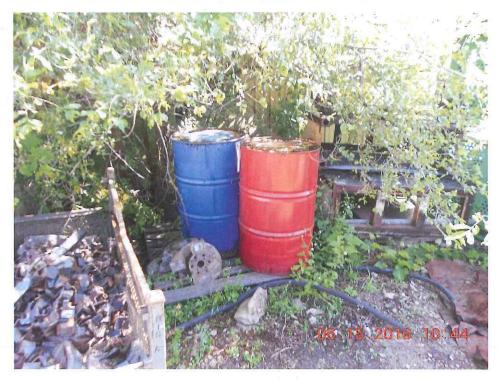
9

The inspector observed two drums located in an outdoor storage area (photographs 9). Both containers appeared heavy to the touch. At the time of the inspection, Mr. Taylor was unaware of their contents. Both drums were affixed with product labels. The inspector could not photograph the labels, as the containers were positioned in close proximity to each other, with the labels turned inward. Nonetheless, the labels identified the materials as: "Isocyanate DOW 3019" and "Dow Styrofoam Mix 2030 Poly 01."

Two containers located in an outdoor area. The drums were positioned so the labels were turned inward. The red drum was labeled isocyanate DOW 3019. The blue drum was labeled Dow Styrofoam Mix 2030 Poly 01.
